SHAKE AND/OR SHUDDER DURING LIGHT THROTTLE ACCELERATION BETWEEN 40 AND 128 KM/H (25 AND 80 MPH) AT A STEADY STATE

#19-NA-018: Shake and/or Shudder During Light Throttle Acceleration Between 40 and 128 KM/H (25 and 80 MPH) at a Steady State - (Aug 25, 2021)

Attention: This bulletin only applies to Mexico and Export Regions outside of the U.S. and Canada.

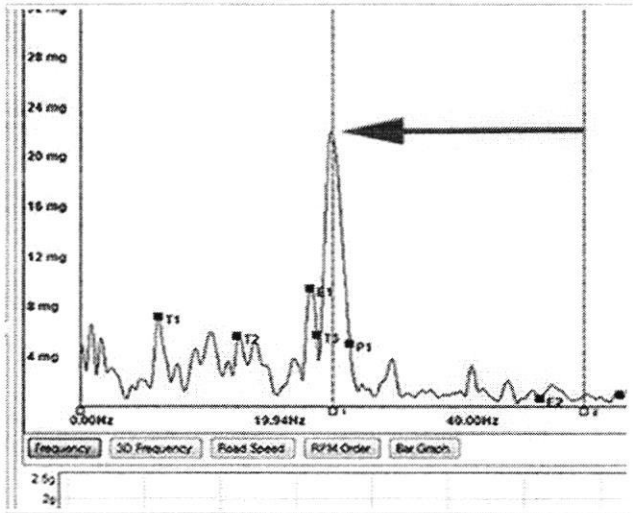
To confirm TCC Shudder, record the PicoScope data while driving in 8th gear in the application specific condition above. Minimize extraneous vibration input by testing on a smooth road and correct any other known vehicle vibration issues (tires, brakes, etc.) before conducting test. If TCC Shudder is present, a vibration peak will appear (highlighted by arrow

below) within +/-2 Hz of the frequency listed in the table above. TCC Shudder vibration frequency is stationary in 8th gear. If the vibration frequency follows vehicle speed or engine speed, then it is NOT TCC Shudder.

In the above illustration, frequency and default view have been selected.
